MARINE INVESTIGATION REPORT

M99L0126

GROUNDING AND CONSTRUCTIVE TOTAL LOSS

THE BULK CARRIER *ALCOR*

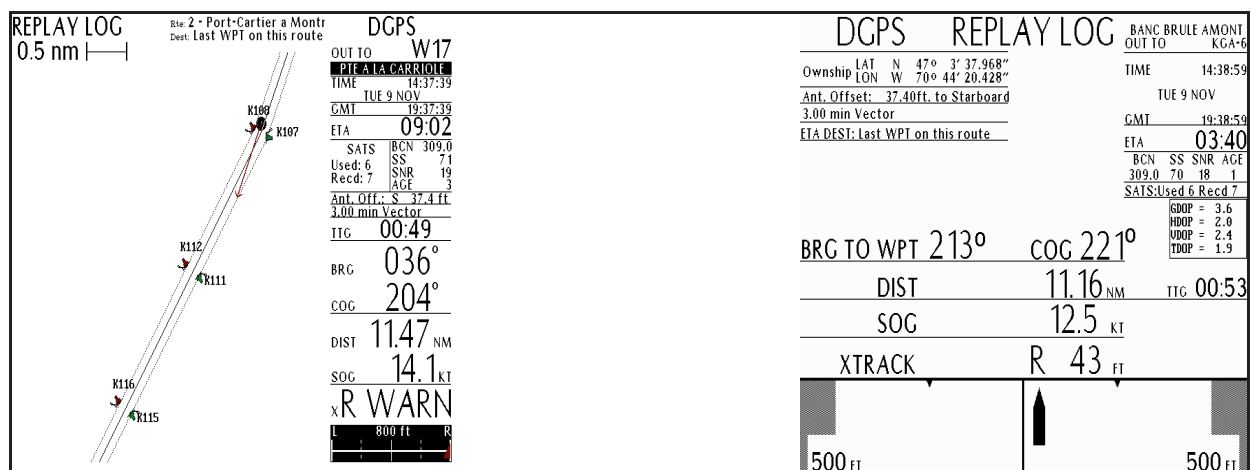
Figure 2. Two possible information displays from Starlink DGPS

The *Alcor* is equipped with all electronic aids to navigation required by international conventions, including X- and S-band radars, supplemented by a global positioning system receiver. Additionally, the pilot had brought on board a portable navigation system that plotted the vessel's progress along the navigable channel. This system, a Starlink DGPS with a laptop display unit, does not show details such as coastline or soundings, but simply plots the vessel's position with respect to the buoyed, navigable channel (see Figure 2).

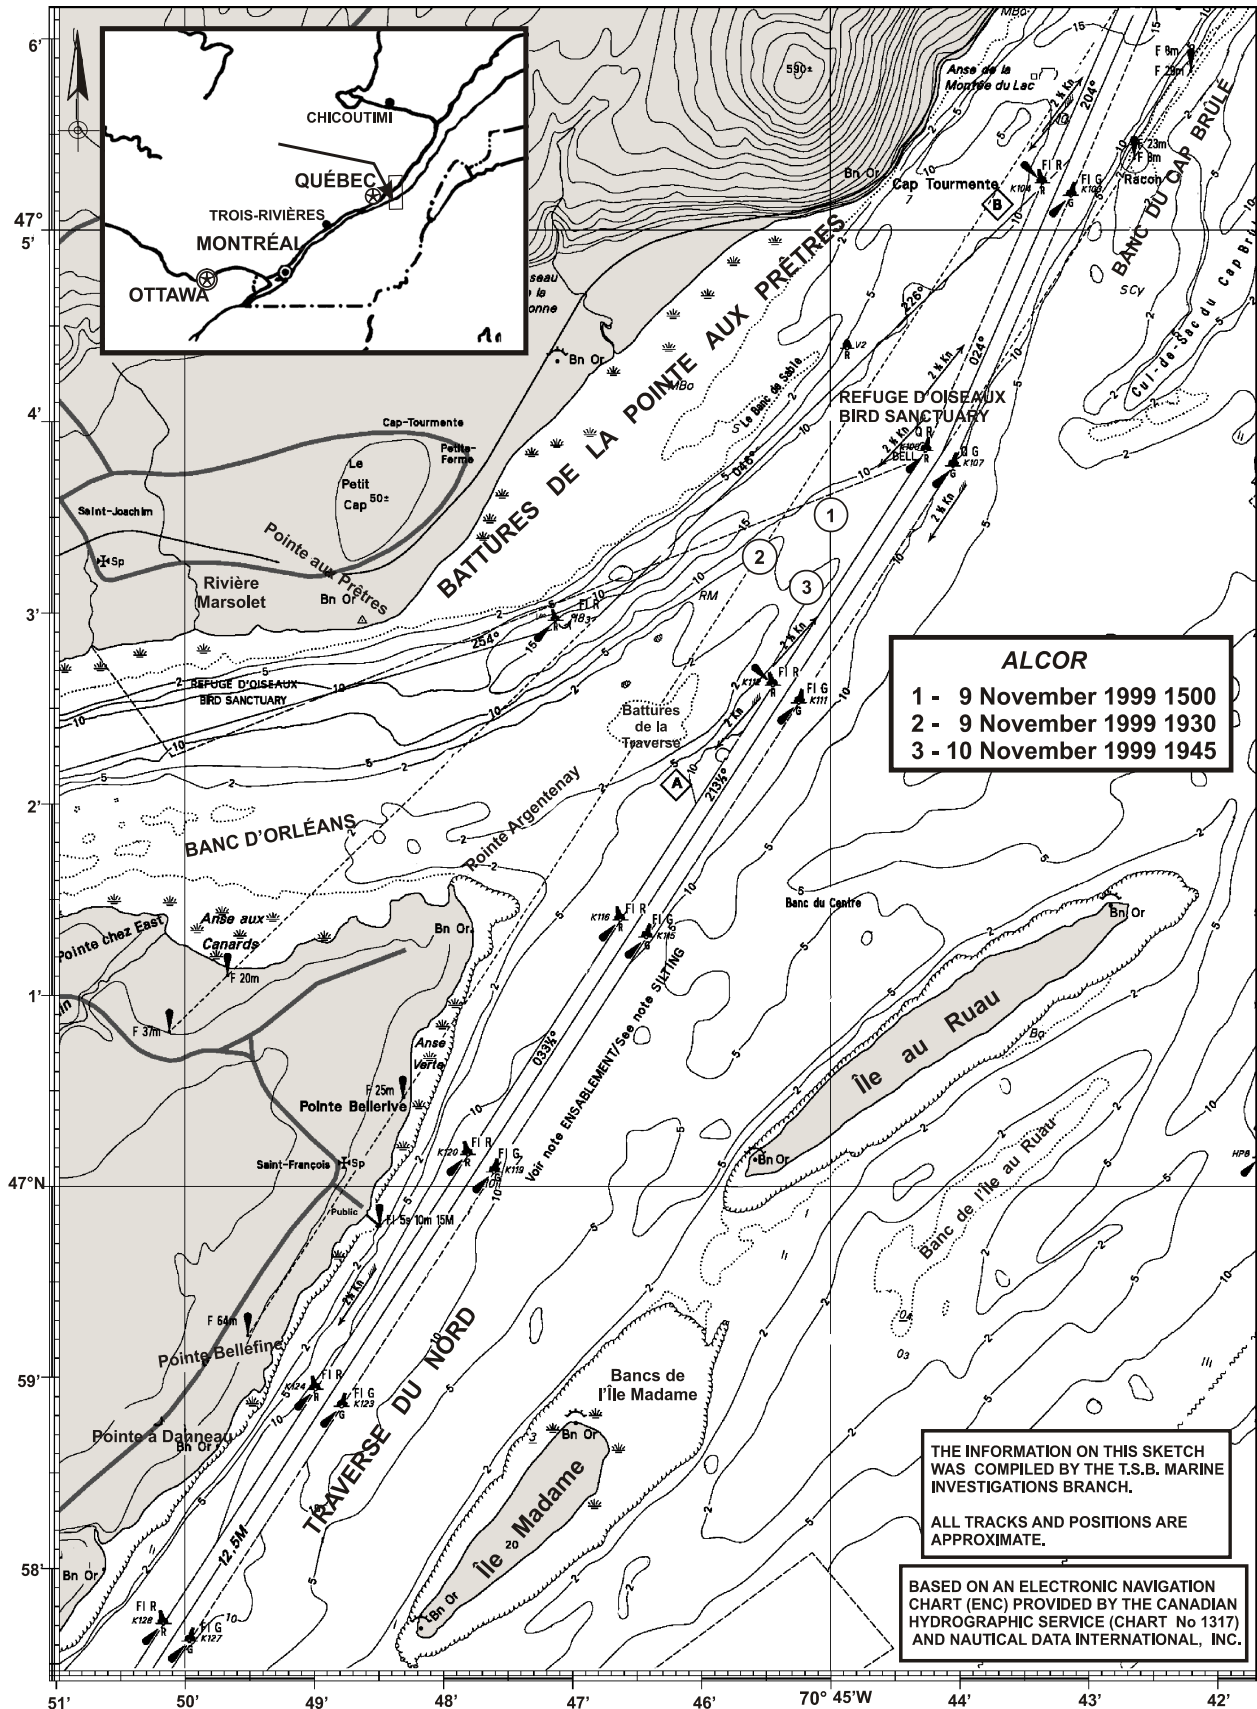
Figure 4. Area chart with grounding positions

course alteration, to starboard, to make the next set of leading lights, also of $213\frac{1}{2}^{\circ}$ T. The only other river traffic in the vicinity was a downbound vessel ahead at between $1\frac{1}{2}$ and 2 nautical miles (nm). (See Figure 4 for General Area Chart.)

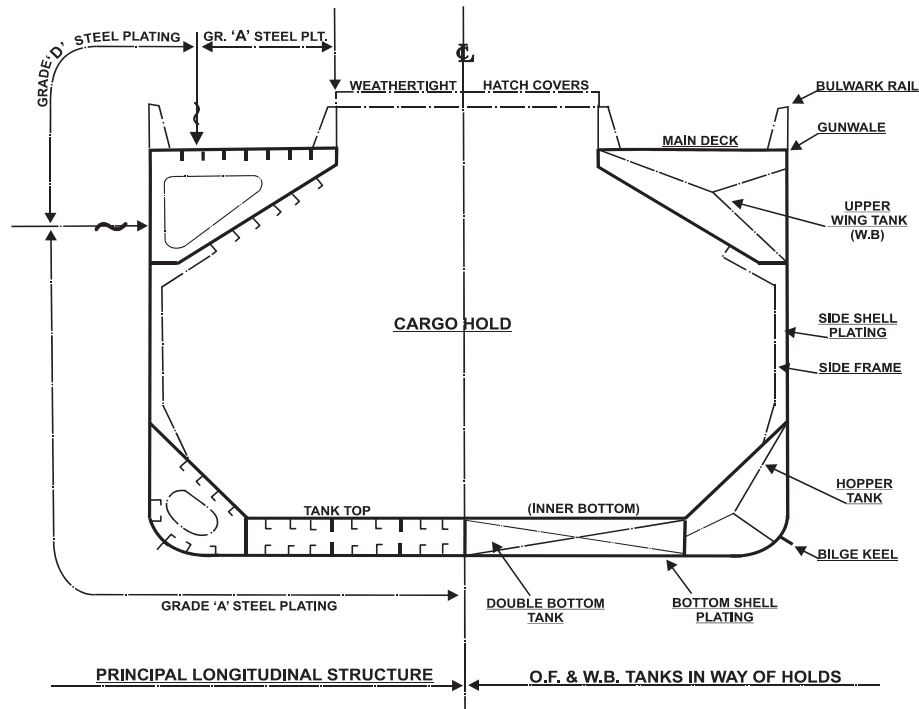
Figure 11. Typical cross section: principal construction details

The hull was generally constructed with shipbuilding quality Grade A mild steel, while the main deck port and starboard side stringer plates and side shell sheer strakes were made of more notch (fracture) resistant Grade D steel. The layout of the principal longitudinal structural members in way of the cargo hatches, holds, upper wing ballast tanks, and double bottom tanks is shown in Figure 11.
